Monitoring Specific Gravity of a forklift used at grocery shop in Auburn, WA

Test date:	June 2005	
Place:	Grocery Shop in Auburn, WA	
Lift Truck:	Electric Clark Lift	
Battery Spec.:	Maker	GNB Technologies
	Model	M2601812517B
	S/N	GCZ0835
	Capacity	1000 Ah
	Voltage	36V
	Yr. Made	2001

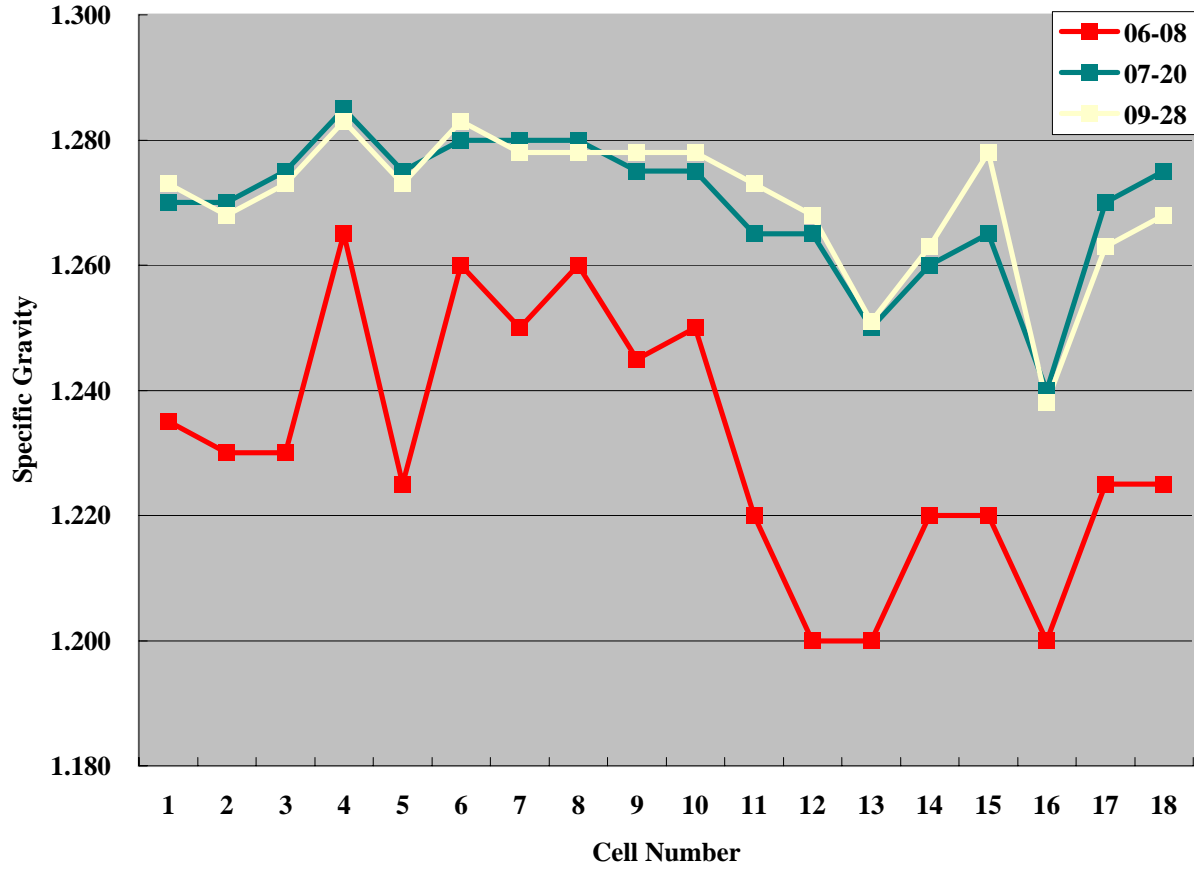
Change in Specific Gravity - TNFS @ Grocery Shop.

Cell / Date	06-08	07-20	09-28
1	1.235	1.270	1.273
2	1.230	1.270	1.268
3	1.230	1.275	1.273
4	1.265	1.285	1.283
5	1.225	1.275	1.273
6	1.260	1.280	1.283
7	1.250	1.280	1.278
8	1.260	1.280	1.278
9	1.245	1.275	1.278
10	1.250	1.275	1.278
11	1.220	1.265	1.273
12	1.200	1.265	1.268
13	1.200	1.250	1.251
14	1.220	1.260	1.263
15	1.220	1.265	1.278
16	1.200	1.240	1.238
17	1.225	1.270	1.263
18	1.225	1.275	1.268
Average S.G.	1.231	1.270	1.270

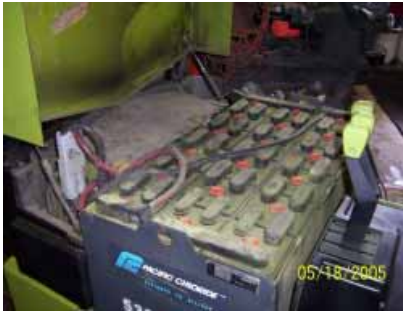
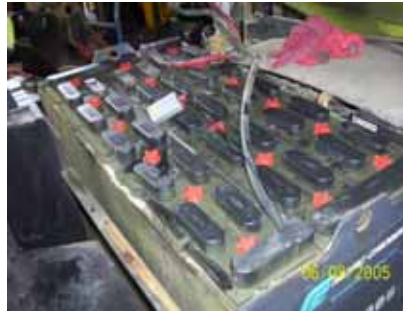
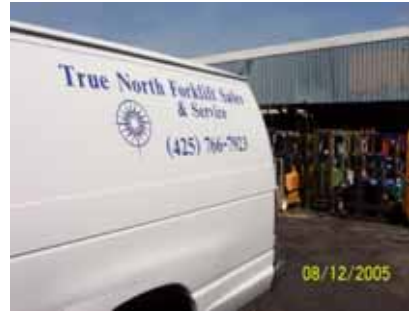
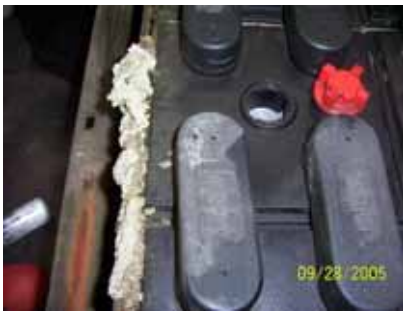
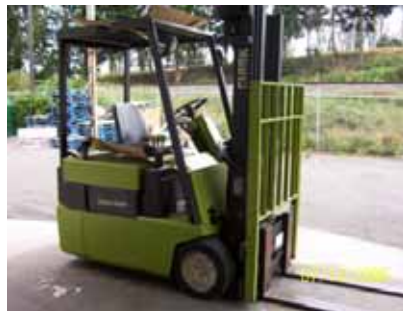
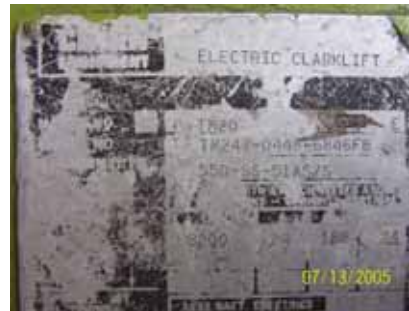
9-28-05 S.G. reading and Voltage w/ and w/o load were measured.
Specific Gravity improved in first 6 weeks, then maintained.
Even initial SG improvement can be seen on cell #16, as seen on photo, white sulfation buildup on top of the case showing physical damage.
To confirm the damage, voltage of each cells were recorded.

White deposit is growing on cel 16 & 17. (Showing physical damage.)

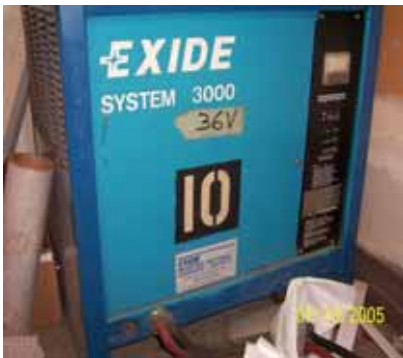
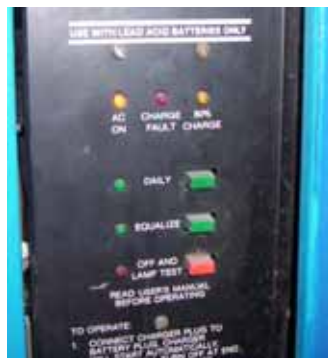
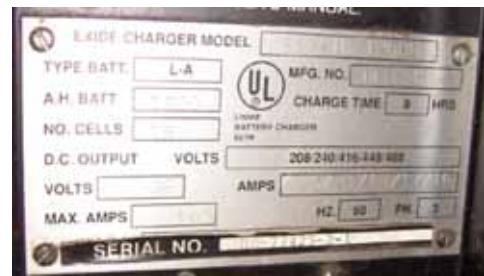
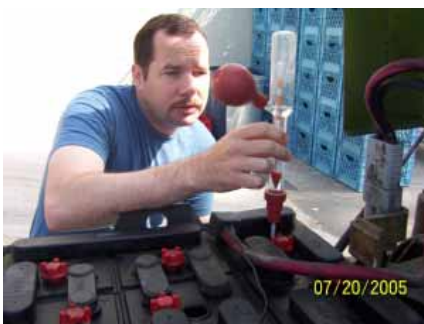
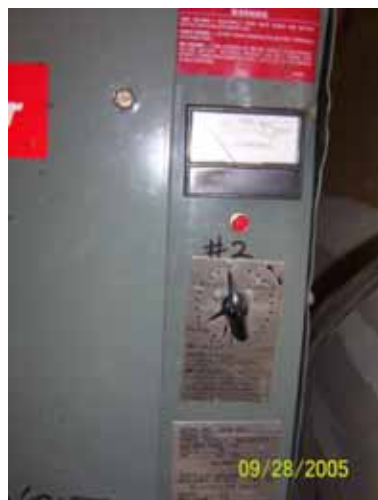
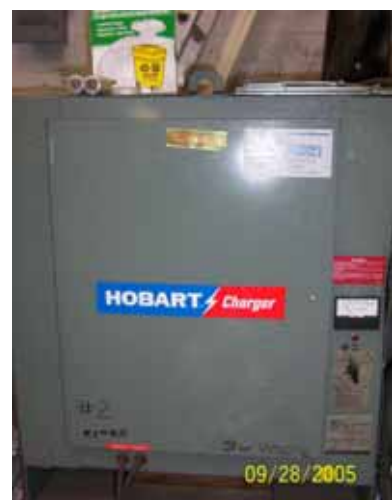
In between Charger's fuse was out and it took a long time to fix.
Charger was replaced with a different charger. -- see photo.
